YOUR ONESURVEY  
**HOME REPORT**

45 Octavia Terrace  
Greenock  
PA16 7SR

# SINGLE SURVEY

<b>Date of Inspection</b>	28/04/2022
---------------------------	------------

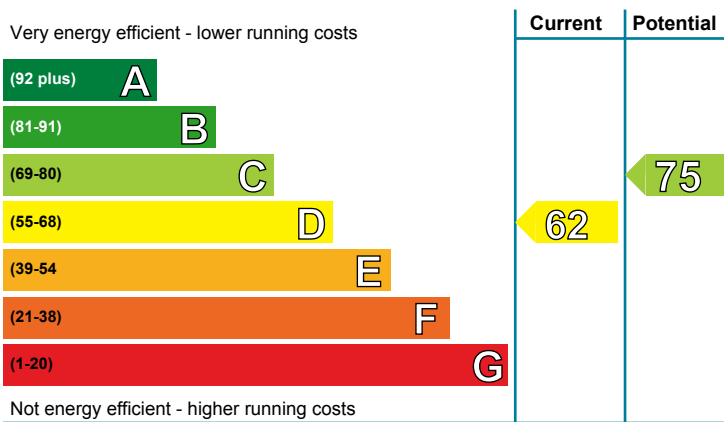
## Energy Efficiency Rating

This graph shows the current efficiency of your home, taking into account both energy efficiency and fuel costs. The higher this rating, the lower your fuel bills are likely to be.

Your current rating is **band D (62)**. The average rating for EPCs in Scotland is **band D (61)**.

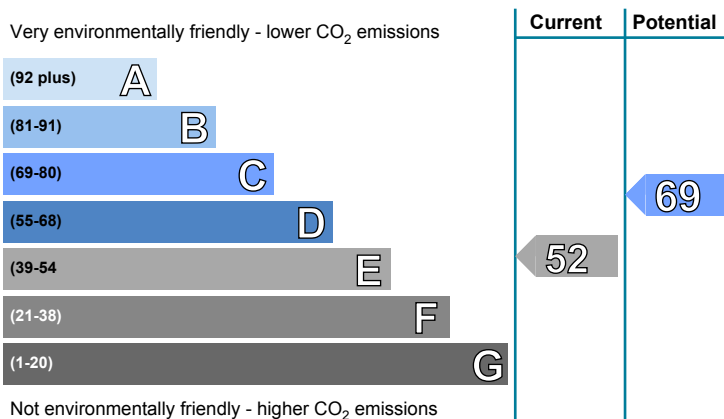
## Environmental Impact (CO<sub>2</sub>) Rating

This graph shows the effect of your home on the environment in terms of carbon dioxide (CO<sub>2</sub>) emissions. The higher the rating, the less impact it has on the environment.
