YOUR ONESURVEY HOME REPORT

86 Auchenbothie Road Port Glasgow PA14 6JD

SINGLE Survey

Single Survey

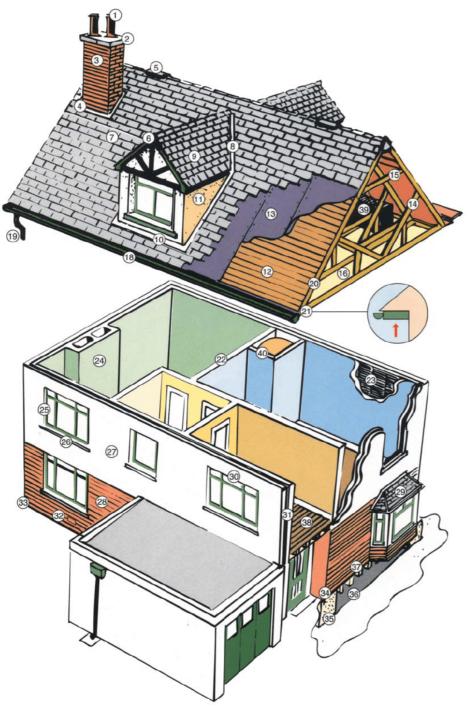
Sectional Diagram showing elements of a typical house

Chimney head (3) Flashing (4)**Ridge ventilation** (5) Ridge board (6) Slates / tiles ി Valley guttering (8) (9) Dormer projection (10) Dormer flashing (11) Dormer cheeks (12) Sarking (13) Roof felt (14) Trusses (15) Collar (16) Insulation (17) Parapet gutter (18) Eaves guttering (19) Rainwater downpipe Verge boards/skews 20 Soffit boards (21) Partiton wall (22) Lath / plaster (23) (24) Chimney breast Window pointing (25) Window sills (26) Rendering (27) (28) Brickwork / pointing (29) Bay window projection (30) Lintels (31) Cavity walls / wall ties (32) Subfloor ventilator 33) Damp proof course Base course (34) Foundations (35) Solum (36) Floor joists (37) Floorboards 38) Water tank (39)
