# YOUR ONESURVEY HOME REPORT

33 Baxter Street Greenock PA15 2DL

## SINGLE SURVEY

# Single Survey

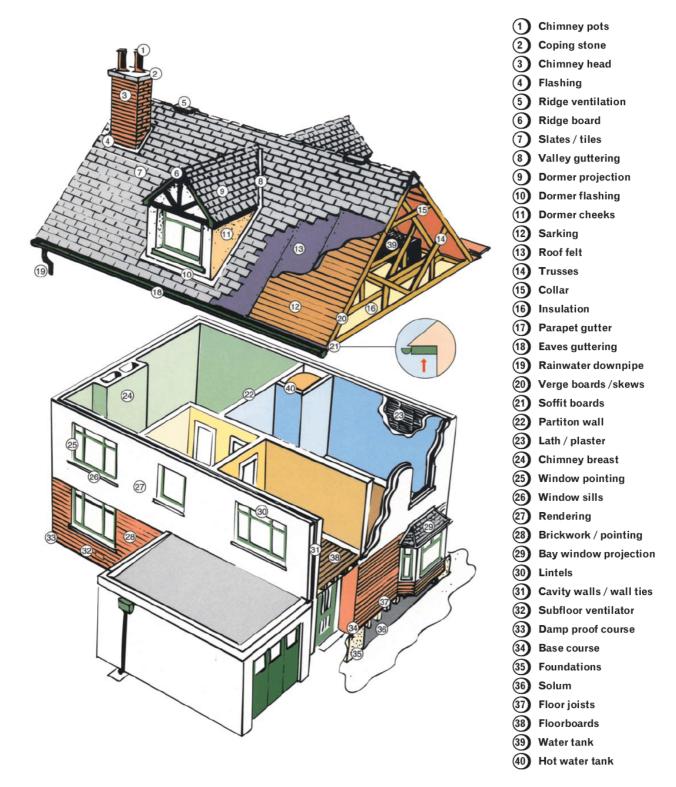
#### Sectional Diagram showing elements of a typical house

Reference may be made in this report to some or all of the above component parts of the property. This diagram may assist you in locating and understanding these items.
