YOUR ONESURVEY
HOME REPORT

178 Inverkip Road
Greenock
PA16 9EX

SINGLE SURVEY

Single Survey

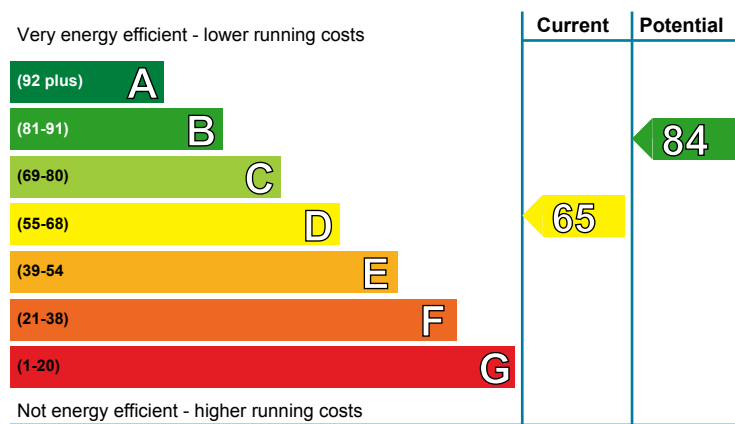
Energy Efficiency Rating

This graph shows the current efficiency of your home, taking into account both energy efficiency and fuel costs. The higher this rating, the lower your fuel bills are likely to be.

Your current rating is **band D (65)**. The average rating for EPCs in Scotland is **band D (61)**.

The potential rating shows the effect of undertaking all of the improvement measures listed within your recommendations report.

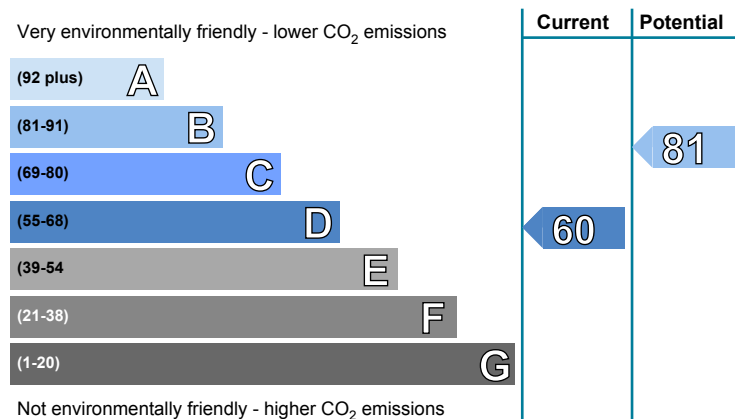
Environmental Impact (CO₂) Rating

This graph shows the effect of your home on the environment in terms of carbon dioxide (CO₂) emissions. The higher the rating, the less impact it has on the environment.
