YOUR ONESURVEY  
**HOME REPORT**

12 Finnie Terrace  
Gourock  
PA19 1TF

# SINGLE SURVEY

A report on the condition of the property, with categories being rated from 1 to 3.

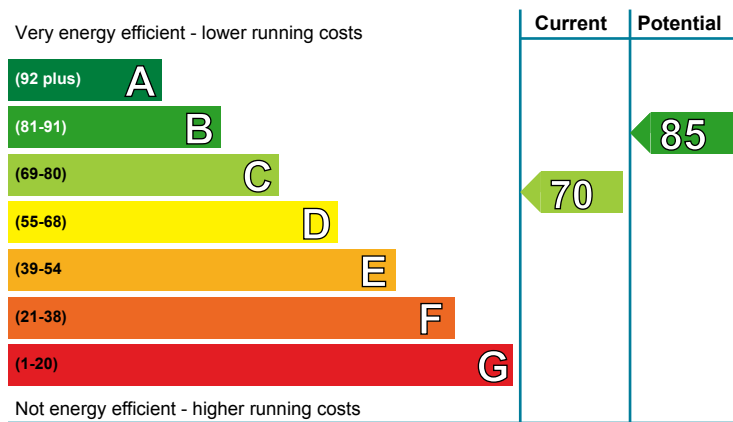
## Energy Efficiency Rating

This graph shows the current efficiency of your home, taking into account both energy efficiency and fuel costs. The higher this rating, the lower your fuel bills are likely to be.

Your current rating is **band C (70)**. The average rating for EPCs in Scotland is **band D (61)**.

The potential rating shows the effect of undertaking all of the improvement measures listed within your recommendations report.

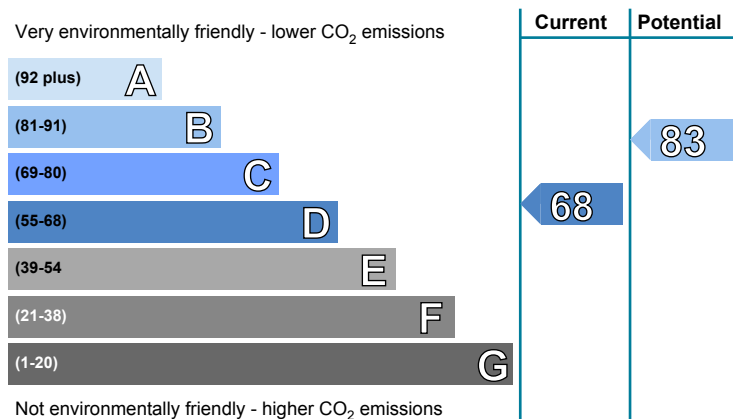
## Environmental Impact (CO<sub>2</sub>) Rating

This graph shows the effect of your home on the environment in terms of carbon dioxide (CO<sub>2</sub>) emissions. The higher the rating, the less impact it has on the environment.
