YOUR ONESURVEY
HOME REPORT

52 Carnoustie Avenue
Gourock
PA19 1HG

SINGLE SURVEY

Single Survey

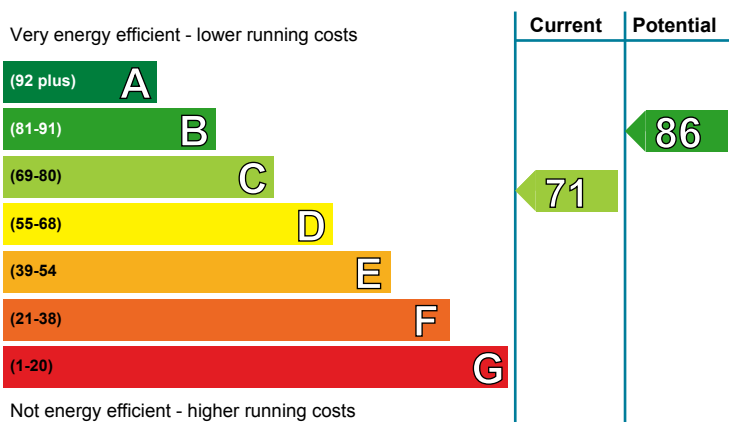
Energy Efficiency Rating

This graph shows the current efficiency of your home, taking into account both energy efficiency and fuel costs. The higher this rating, the lower your fuel bills are likely to be.

Your current rating is **band C (71)**. The average rating for EPCs in Scotland is **band D (61)**.

The potential rating shows the effect of undertaking all of the improvement measures listed within your recommendations report.
