YOUR ONESURVEY  
**HOME REPORT**

Flat 2/2  
23 Royal Street  
Gourock  
PA19 1PJ

# SINGLE SURVEY

# Single Survey

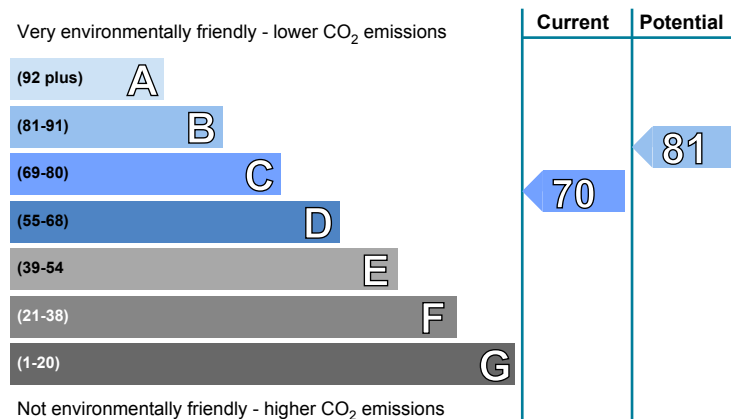
### Environmental Impact (CO<sub>2</sub>) Rating

This graph shows the effect of your home on the environment in terms of carbon dioxide (CO<sub>2</sub>) emissions. The higher the rating, the less impact it has on the environment.
