YOUR ONESURVEY  
**HOME REPORT**

4d Houston Street  
Greenock  
PA16 8ND

# SINGLE SURVEY

# Single Survey

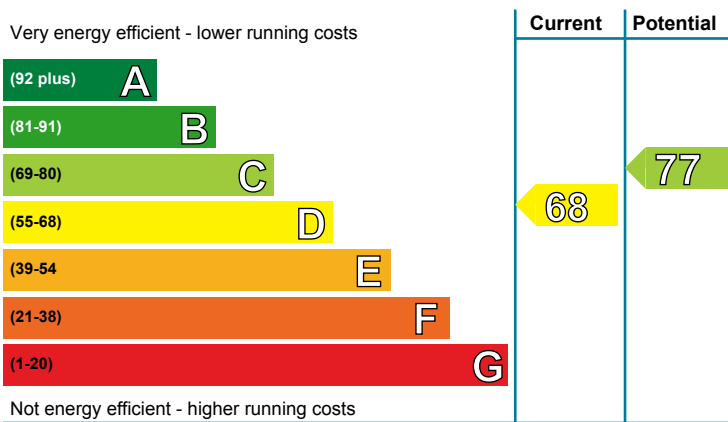
## Energy Efficiency Rating

This graph shows the current efficiency of your home, taking into account both energy efficiency and fuel costs. The higher this rating, the lower your fuel bills are likely to be.

Your current rating is **band D (68)**. The average rating for EPCs in Scotland is **band D (61)**.

The potential rating shows the effect of undertaking all of the improvement measures listed within your recommendations report.

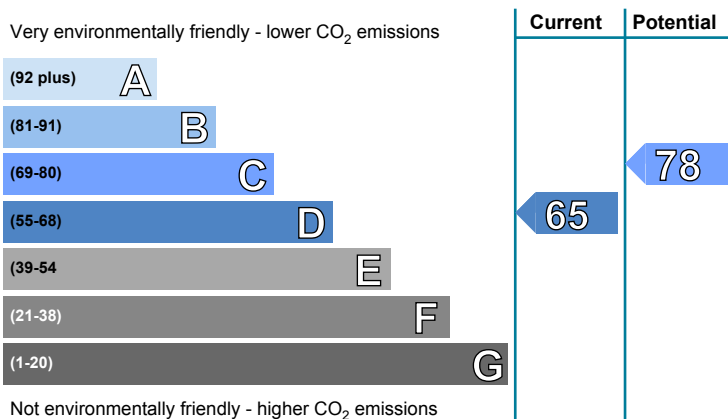
## Environmental Impact (CO<sub>2</sub>) Rating

This graph shows the effect of your home on the environment in terms of carbon dioxide (CO<sub>2</sub>) emissions. The higher the rating, the less impact it has on the environment.
