Energy Performance Certificate (EPC)

15 ASHTON COURT, ALBERT ROAD, GOUROCK, PA19 1LT

Dwelling type: Mid-floor flat
Date of assessment: 29 June 2023
Date of certificate: 02 July 2023
Total floor area: 40 m²
Primary Energy Indicator: 276 kWh/m²/year

Single Survey

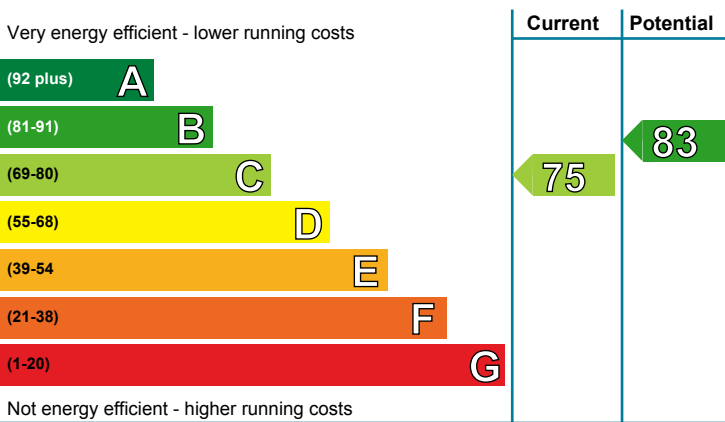
Energy Efficiency Rating

This graph shows the current efficiency of your home, taking into account both energy efficiency and fuel costs. The higher this rating, the lower your fuel bills are likely to be.

Your current rating is **band C (75)**. The average rating for EPCs in Scotland is **band D (61)**.

The potential rating shows the effect of undertaking all of the improvement measures listed within your recommendations report.

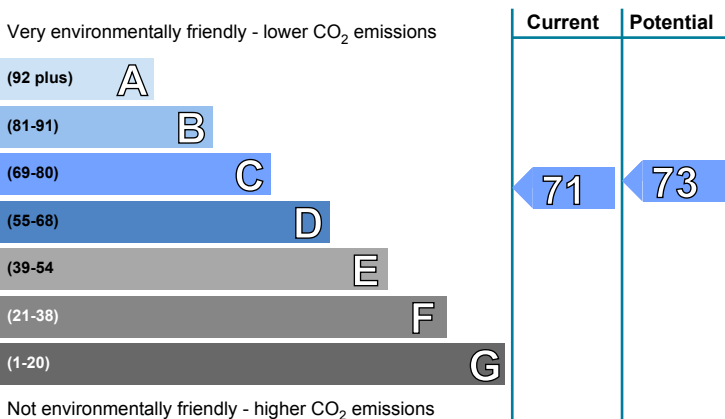
Environmental Impact (CO₂) Rating

This graph shows the effect of your home on the environment in terms of carbon dioxide (CO₂) emissions. The higher the rating, the less impact it has on the environment.

The potential rating shows the effect of undertaking all of the improvement measures listed within your recommendations report.
