YOUR ONESURVEY  
**HOME REPORT**

5 Dorset Road  
Greenock  
PA16 0LL

# SINGLE SURVEY

A report on the condition of the property, with categories being rated from 1 to 3.

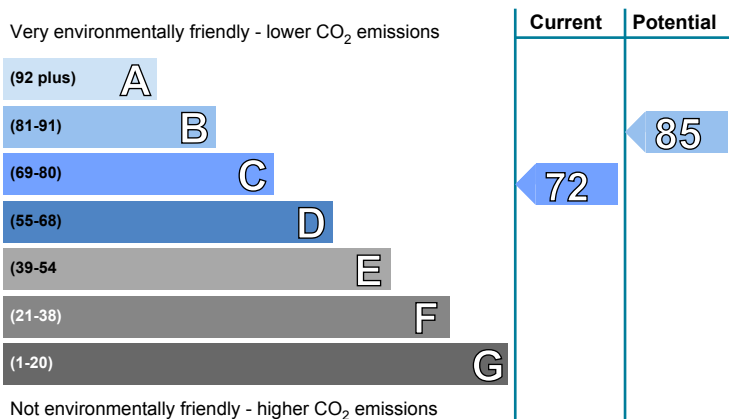
### Environmental Impact (CO<sub>2</sub>) Rating

This graph shows the effect of your home on the environment in terms of carbon dioxide (CO<sub>2</sub>) emissions. The higher the rating, the less impact it has on the environment.
