YOUR ONESURVEY HOME REPORT

Single Survey

Selling address	1 Davey Street Greenock PA16 7JA
-----------------	--

Prepared by	Michael McDade, MRICS J & E Shepherd - Greenock

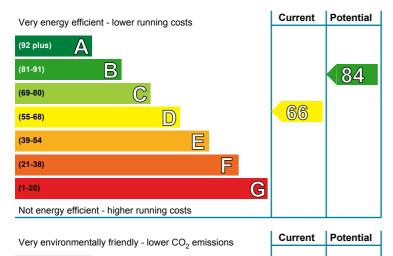
Energy Efficiency Rating

This graph shows the current efficiency of your home, taking into account both energy efficiency and fuel costs. The higher this rating, the lower your fuel bills are likely to be.
