YOUR ONESURVEY
HOME REPORT

6 Ascog Place
Wemyss Bay
PA18 6DZ

SINGLE SURVEY

Single Survey

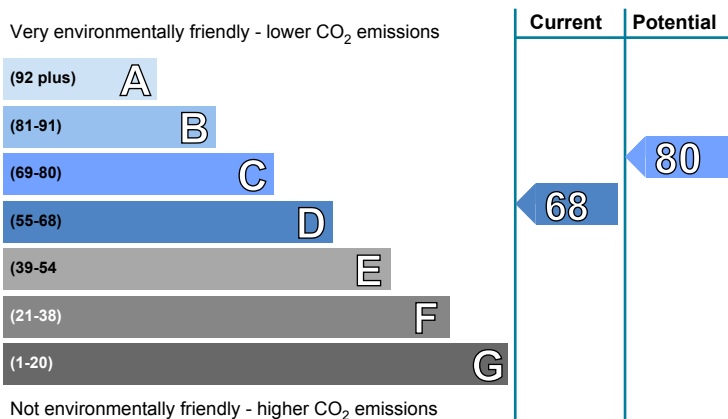
Environmental Impact (CO₂) Rating

This graph shows the effect of your home on the environment in terms of carbon dioxide (CO₂) emissions. The higher the rating, the less impact it has on the environment.
