YOUR ONESURVEY  
**HOME REPORT**

Flat 2/1  
4 John Street  
Gourock  
PA191PR

# SINGLE SURVEY

A report on the condition of the property, with categories being rated from 1 to 3.

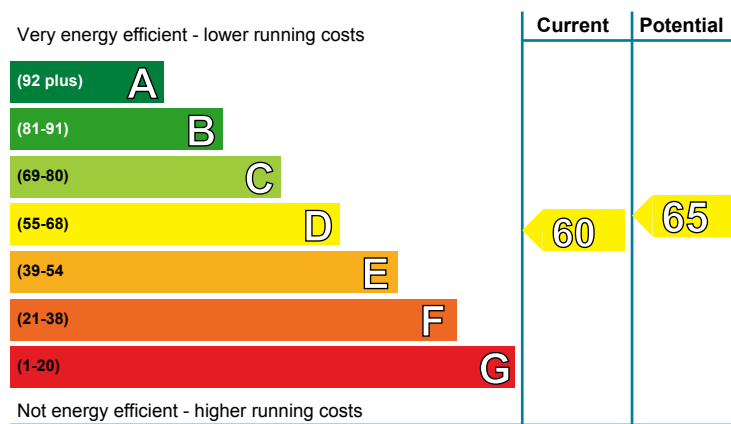
## Energy Efficiency Rating

This graph shows the current efficiency of your home, taking into account both energy efficiency and fuel costs. The higher this rating, the lower your fuel bills are likely to be.

Your current rating is **band D (60)**. The average rating for EPCs in Scotland is **band D (61)**.

The potential rating shows the effect of undertaking all of the improvement measures listed within your recommendations report.

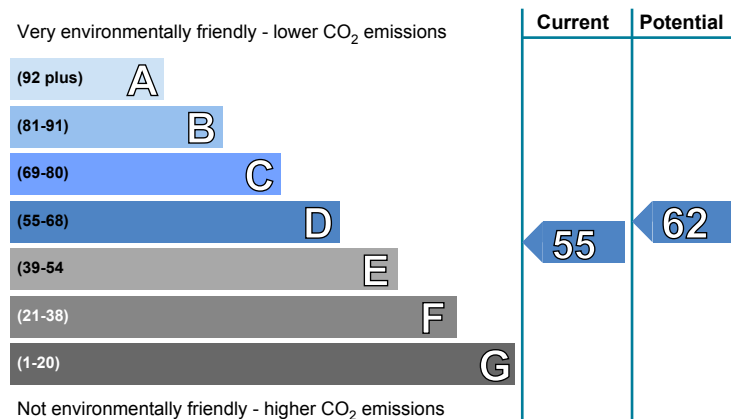
## Environmental Impact (CO<sub>2</sub>) Rating

This graph shows the effect of your home on the environment in terms of carbon dioxide (CO<sub>2</sub>) emissions. The higher the rating, the less impact it has on the environment.
