YOUR ONESURVEY  
**HOME REPORT**

13 Bow Road  
Greenock  
PA16 7JF

# SINGLE SURVEY

A report on the condition of the property, with categories being rated from 1 to 3.

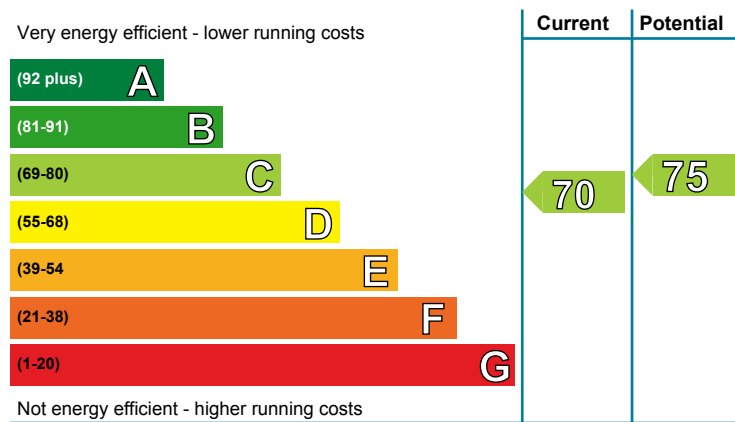
## Energy Efficiency Rating

This graph shows the current efficiency of your home, taking into account both energy efficiency and fuel costs. The higher this rating, the lower your fuel bills are likely to be.

Your current rating is **band C (70)**. The average rating for EPCs in Scotland is **band D (61)**.

The potential rating shows the effect of undertaking all of the improvement measures listed within your recommendations report.

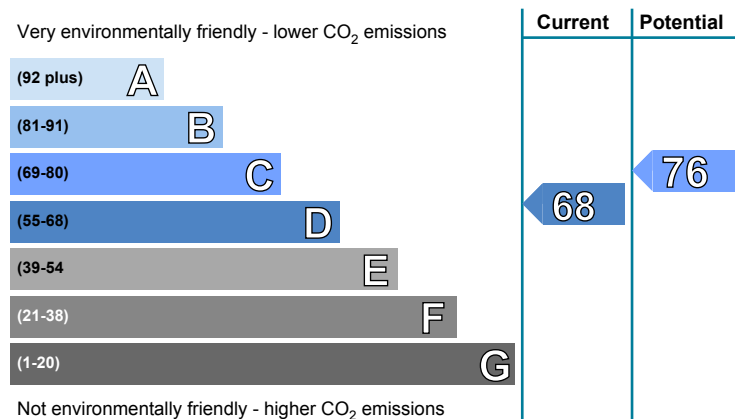
## Environmental Impact (CO<sub>2</sub>) Rating

This graph shows the effect of your home on the environment in terms of carbon dioxide (CO<sub>2</sub>) emissions. The higher the rating, the less impact it has on the environment.
