Home Report

Scottish Single Survey

Property address	24 Wemyss Point Undercliff Road Wemyss Bay PA18 6AQ
-------------------------	--

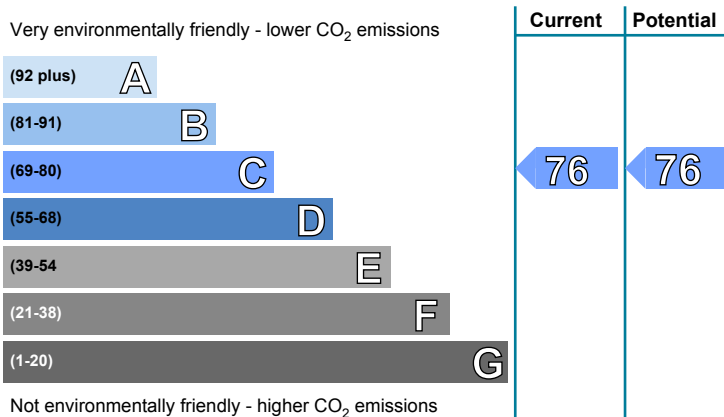
Environmental Impact (CO₂) Rating

This graph shows the effect of your home on the environment in terms of carbon dioxide (CO₂) emissions. The higher the rating, the less impact it has on the environment.
