YOUR ONESURVEY HOME REPORT

11 Oakfield Terrace Greenock PA15 2AH

Single Survey

Date of Inspection	27/03/2024
Prepared by	Michael McDade, MRICS J & E Shepherd - Greenock

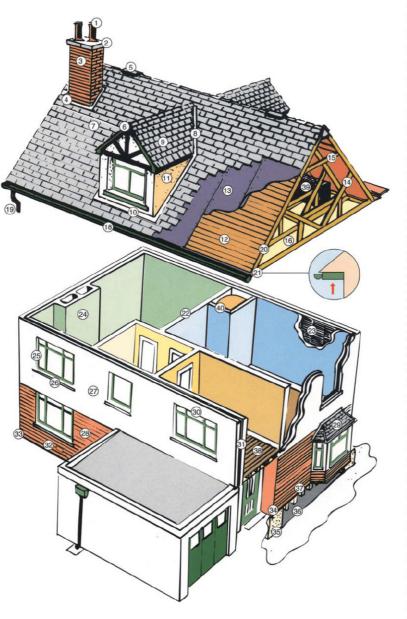
Sectional Diagram showing elements of a typical house

Reference may be made in this report to some or all of the above component parts of the property. This diagram may assist you in locating and understanding these items.
