YOUR ONESURVEY HOME REPORT

87 Lairds Dyke Inverkip, Greenock PA16 0FN

Single Survey

Survey report on:

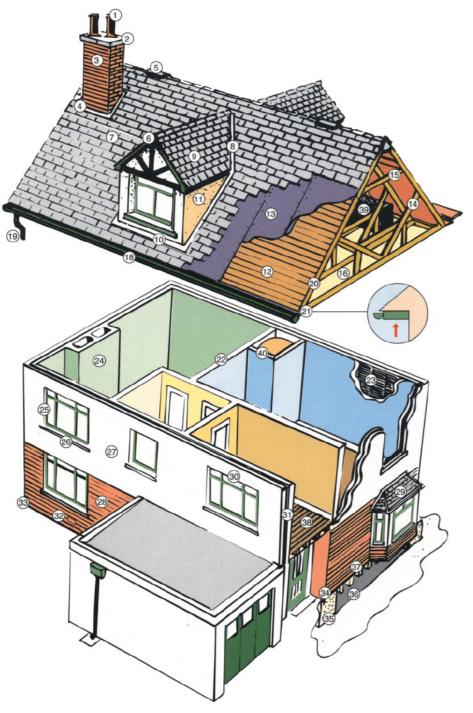
Sectional Diagram showing elements of a typical house

Reference may be made in this report to some or all of the above component parts of the property. This diagram may assist you in locating and understanding these items.

1	Chimney pots
$\check{2}$	Coping stone
3	Chimney head
(4)	Flashing
5	Ridge ventilation
6	Ridge board
$\overline{\mathbf{O}}$	Slates / tiles
8	Valley guttering
9	Dormer projection
10	Dormer flashing
11	Dormer cheeks
12	Sarking
13	Roof felt
14	Trusses
15	Collar
16	Insulation
17	Parapet gutter
18	Eaves guttering
19	Rainwater downpipe
20	Verge boards /skews
21	Soffit boards
22	Partiton wall
23	Lath / plaster
24	Chimney breast
25	Window pointing
26	Window sills
27	Rendering
28	Brickwork / pointing
29	Bay window projection
30	Lintels
\leq	Cavity walls / wall ties
32	Subfloor ventilator
33	Damp proof course
34	Base course
35	
\leq	Solum
\leq	Floor joists
\leq	Floorboards
39	Water tank
(40)	Hot water tank
