Home Report

Property: **70
Luss Avenue
Greenock
Inverclyde
PA15 3EG**

70 LUSS AVENUE, GREENOCK, PA15 3EG

Dwelling type: Mid-terrace house
Date of assessment: 04 May 2023
Date of certificate: 04 May 2023
Total floor area: 61 m²
Primary Energy Indicator: 213 kWh/m²/year

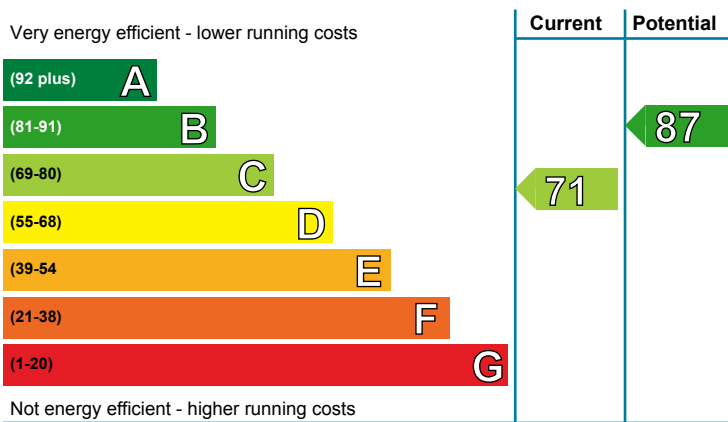
Energy Efficiency Rating

This graph shows the current efficiency of your home, taking into account both energy efficiency and fuel costs. The higher this rating, the lower your fuel bills are likely to be.

Your current rating is **band C (71)**. The average rating for EPCs in Scotland is **band D (61)**.

The potential rating shows the effect of undertaking all of the improvement measures listed within your recommendations report.

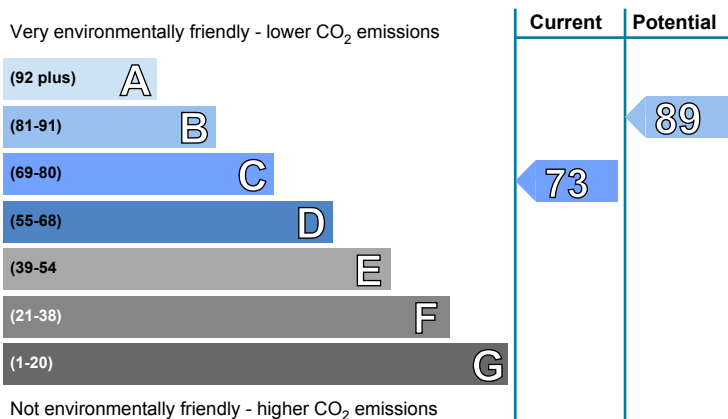
Environmental Impact (CO₂) Rating

This graph shows the effect of your home on the environment in terms of carbon dioxide (CO₂) emissions. The higher the rating, the less impact it has on the environment.

The potential rating shows the effect of undertaking all of the improvement measures listed within your recommendations report.
