YOUR ONESURVEY HOME REPORT

2 Preston Place Gourock PA19 1LF

Single Survey

Date of Inspection	13/06/2024
Prepared by	Michael McDade, MRICS J & E Shepherd - Greenock

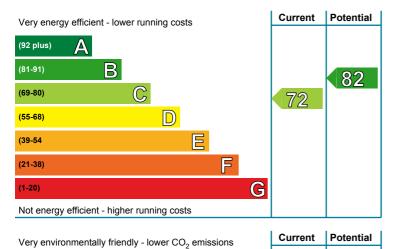
Energy Efficiency Rating

This graph shows the current efficiency of your home, taking into account both energy efficiency and fuel costs. The higher this rating, the lower your fuel bills are likely to be.
