YOUR ONESURVEY
HOME REPORT

1 Glen Douglas Road
Greenock
PA16 9NP

SINGLE SURVEY

Single Survey

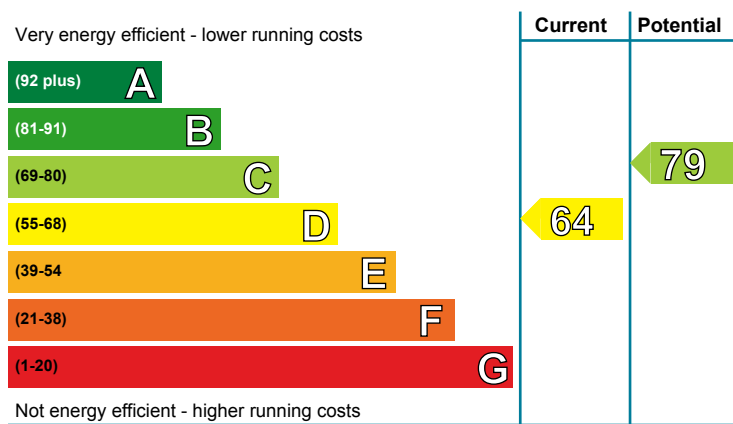
Energy Efficiency Rating

This graph shows the current efficiency of your home, taking into account both energy efficiency and fuel costs. The higher this rating, the lower your fuel bills are likely to be.

Your current rating is **band D (64)**. The average rating for EPCs in Scotland is **band D (61)**.

The potential rating shows the effect of undertaking all of the improvement measures listed within your recommendations report.

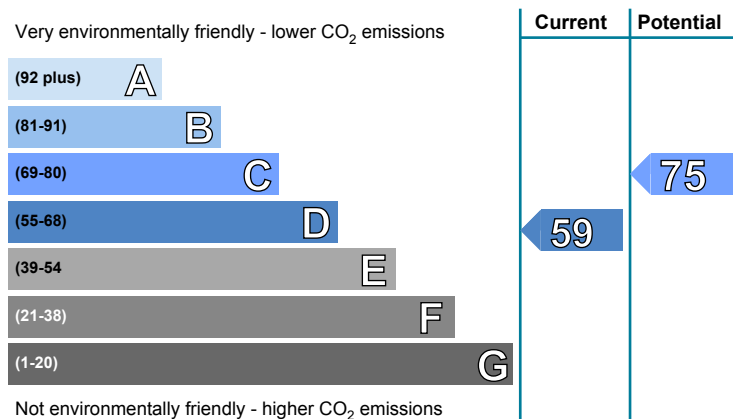
Environmental Impact (CO₂) Rating

This graph shows the effect of your home on the environment in terms of carbon dioxide (CO₂) emissions. The higher the rating, the less impact it has on the environment.
