YOUR ONESURVEY
HOME REPORT

Flat 2/2
82 Albert Road
Gourock
PA19 1NN

Single Survey

Customer	Mr. Robert Ball
Selling address	Flat 2/2 82 Albert Road Gourock PA19 1NN
Date of Inspection	16/07/2024
Prepared by	Alan Devlin, Assoc.RICS Greenock - Allied Surveyors Scotland Ltd

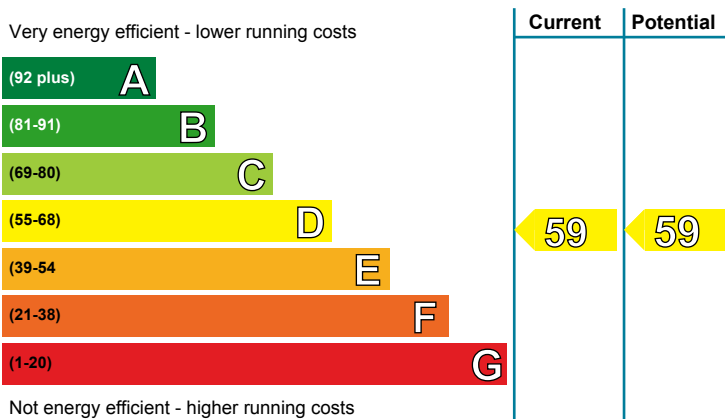
Energy Efficiency Rating

This graph shows the current efficiency of your home, taking into account both energy efficiency and fuel costs. The higher this rating, the lower your fuel bills are likely to be.

Your current rating is **band D (59)**. The average rating for EPCs in Scotland is **band D (61)**.

The potential rating shows the effect of undertaking all of the improvement measures listed within your recommendations report.

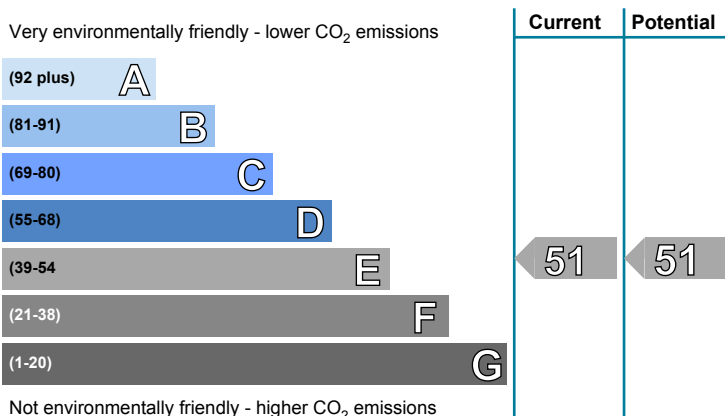
Environmental Impact (CO₂) Rating

This graph shows the effect of your home on the environment in terms of carbon dioxide (CO₂) emissions. The higher the rating, the less impact it has on the environment.
