# YOUR ONESURVEY HOME REPORT

Flat 2/1 2 Silver Birch Wynd Port Glasgow PA14 6QY

# SINGLE Survey

Date of Inspection	30/07/2024
Prepared by	Michael McDade, MRICS J & E Shepherd - Greenock

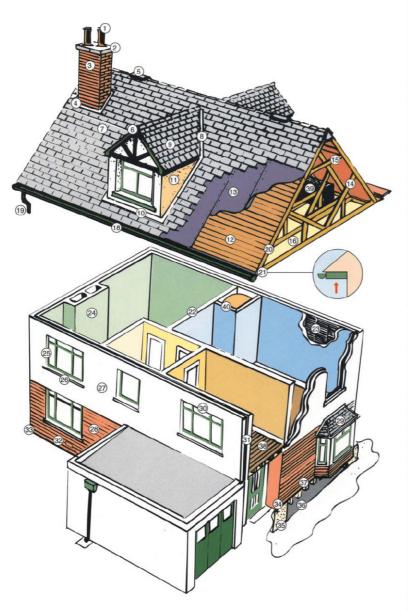
#### Sectional Diagram showing elements of a typical house

Reference may be made in this report to some or all of the above component parts of the property. This diagram may assist you in locating and understanding these items.
