YOUR ONESURVEY  
**HOME REPORT**

31 Inverkip Road  
Greenock  
PA16 9AY

# SINGLE SURVEY

A report on the condition of the property, with categories being rated from 1 to 3.

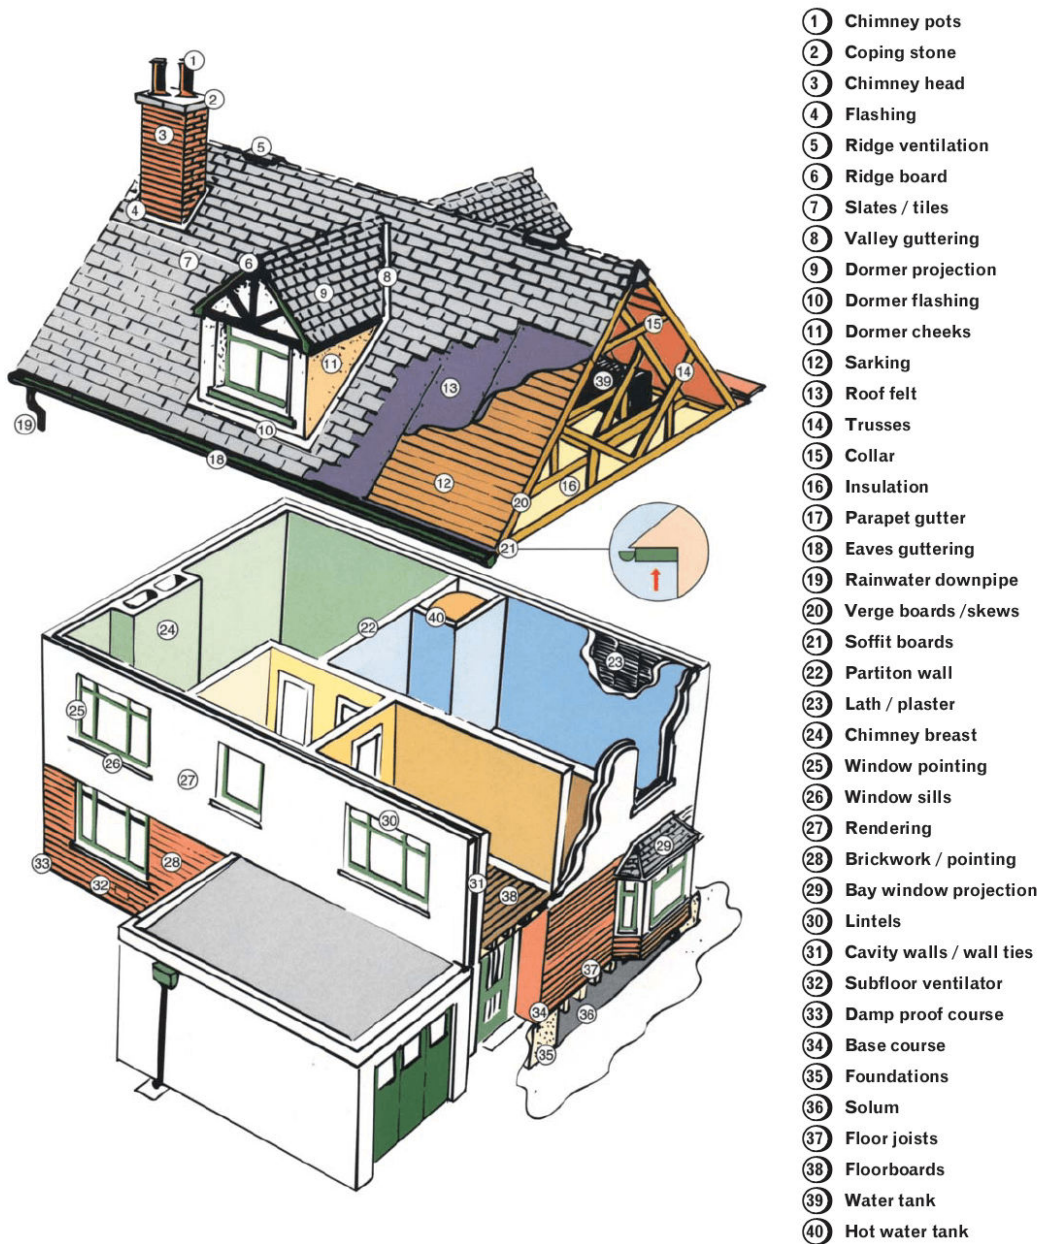
## Sectional Diagram showing elements of a typical house

Reference may be made in this report to some or all of the above component parts of the property. This diagram may assist you in locating and understanding these items.

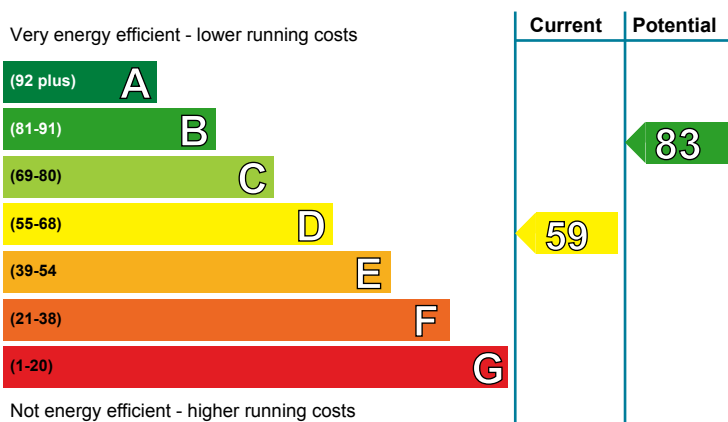
## Energy Efficiency Rating

This graph shows the current efficiency of your home, taking into account both energy efficiency and fuel costs. The higher this rating, the lower your fuel bills are likely to be.

Your current rating is **band D (59)**. The average rating for EPCs in Scotland is **band D (61)**.

The potential rating shows the effect of undertaking all of the improvement measures listed within your recommendations report.
