YOUR ONESURVEY  
**HOME REPORT**

14 Cambridge Avenue  
Gourock  
PA19 1XT

# SINGLE SURVEY

A report on the condition of the property, with categories being rated from 1 to 3.

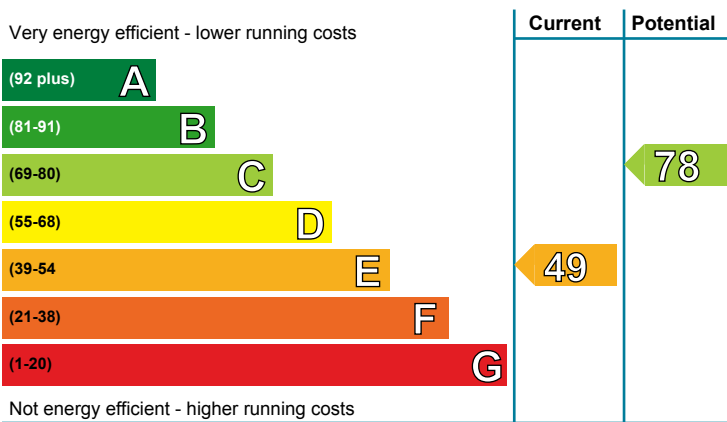
## Energy Efficiency Rating

This graph shows the current efficiency of your home, taking into account both energy efficiency and fuel costs. The higher this rating, the lower your fuel bills are likely to be.

Your current rating is **band E (49)**. The average rating for EPCs in Scotland is **band D (61)**.

The potential rating shows the effect of undertaking all of the improvement measures listed within your recommendations report.

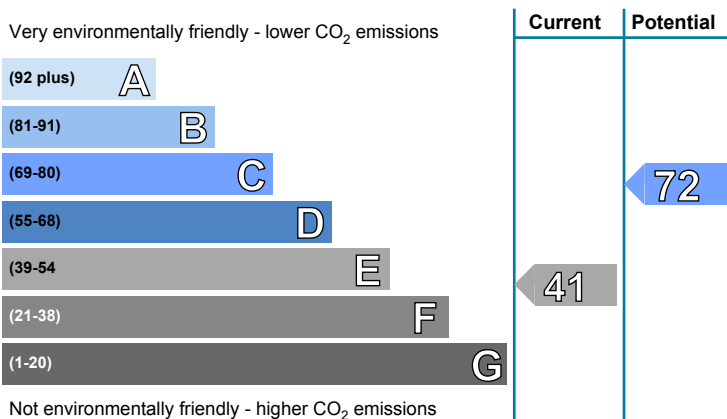
## Environmental Impact (CO<sub>2</sub>) Rating

This graph shows the effect of your home on the environment in terms of carbon dioxide (CO<sub>2</sub>) emissions. The higher the rating, the less impact it has on the environment.
