YOUR ONESURVEY HOME REPORT

Flat 1/2 28 Newton Street Greenock PA16 8SL

SINGLE SURVEY

Customer	Ms. Rachel Marshall	
Selling address	Flat 1/2	
	28 Newton Street	
	Greenock	
	PA16 8SL	
Date of Inspection	28/10/2024	
Prepared by	Michael McDade, MRICS J & E Shepherd - Greenock

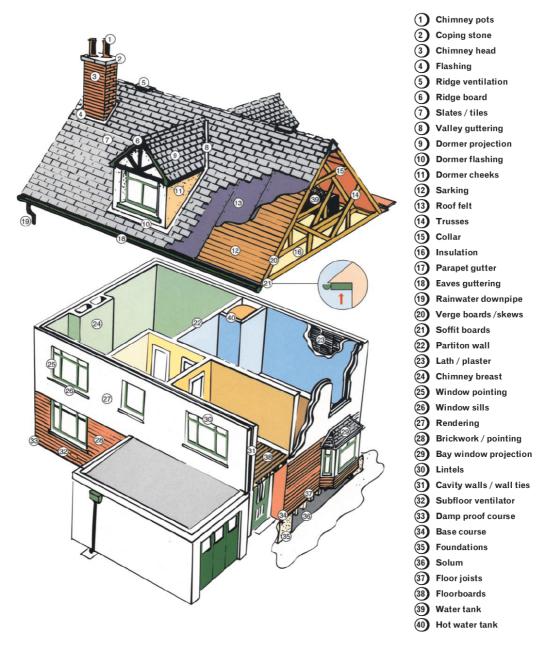
Sectional Diagram showing elements of a typical house

Reference may be made in this report to some or all of the above component parts of the property. This diagram may assist you in locating and understanding these items.
