YOUR ONESURVEY  
**HOME REPORT**

21a Albert Road  
Gourock  
PA19 1NH

# SINGLE SURVEY

# Single Survey

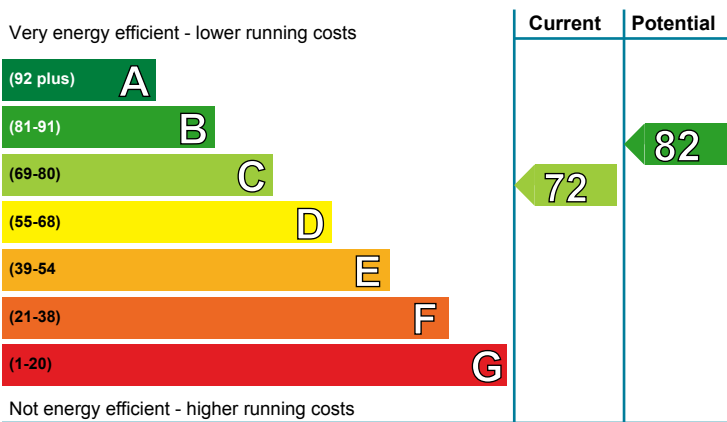
## Energy Efficiency Rating

This graph shows the current efficiency of your home, taking into account both energy efficiency and fuel costs. The higher this rating, the lower your fuel bills are likely to be.

Your current rating is **band C (72)**. The average rating for EPCs in Scotland is **band D (61)**.

The potential rating shows the effect of undertaking all of the improvement measures listed within your recommendations report.

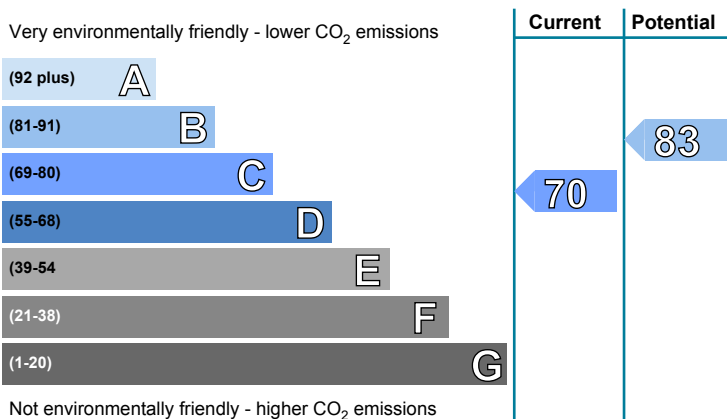
## Environmental Impact (CO<sub>2</sub>) Rating

This graph shows the effect of your home on the environment in terms of carbon dioxide (CO<sub>2</sub>) emissions. The higher the rating, the less impact it has on the environment.
