YOUR ONESURVEY
HOME REPORT

205 Westmorland Road
Greenock
PA16 0TU

SINGLE SURVEY

Single Survey

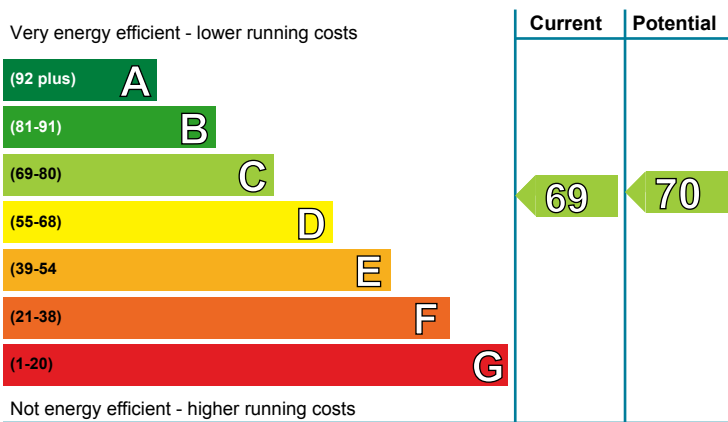
Energy Efficiency Rating

This graph shows the current efficiency of your home, taking into account both energy efficiency and fuel costs. The higher this rating, the lower your fuel bills are likely to be.

Your current rating is **band C (69)**. The average rating for EPCs in Scotland is **band D (61)**.

The potential rating shows the effect of undertaking all of the improvement measures listed within your recommendations report.

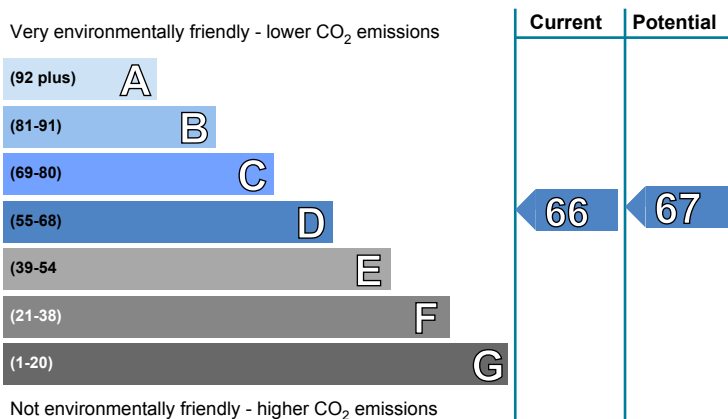
Environmental Impact (CO₂) Rating

This graph shows the effect of your home on the environment in terms of carbon dioxide (CO₂) emissions. The higher the rating, the less impact it has on the environment.
