YOUR ONESURVEY HOME REPORT

4 Blairbeg Place Gourock PA19 1BE PREPARED FOR

SINGLE SURVEY

Customer	Anthony & Liz Smith
Selling address	4 Blairbeg Place
	Gourock
	PA19 1BE
Date of Inspection	05/02/2025
Prepared by	Michael McDade, MRICS J & E Shepherd - Greenock

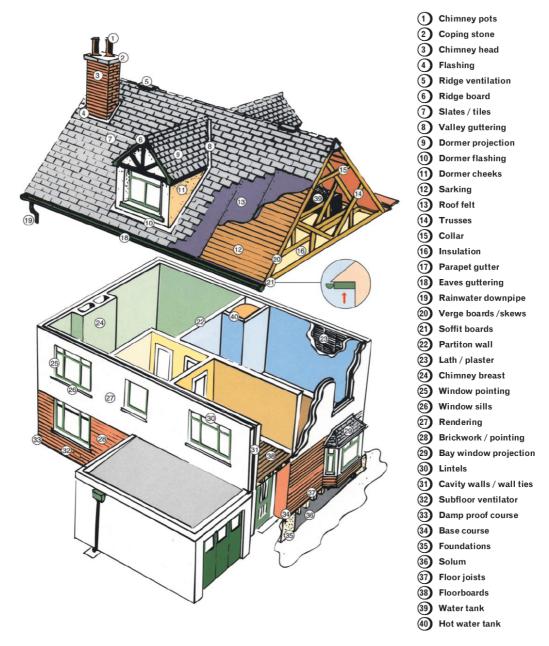
Sectional Diagram showing elements of a typical house

Reference may be made in this report to some or all of the above component parts of the property. This diagram may assist you in locating and understanding these items.
