Survey report on:

Property Address	24 Finbraken Drive Gourock PA19 1BF
Customer	Mr A Kayes & Mrs M Kayes
Date of Inspection	13/02/2025
Prepared by	Andrew G Scrimgeour Harvey Donaldson & Gibson Chartered Surveyors

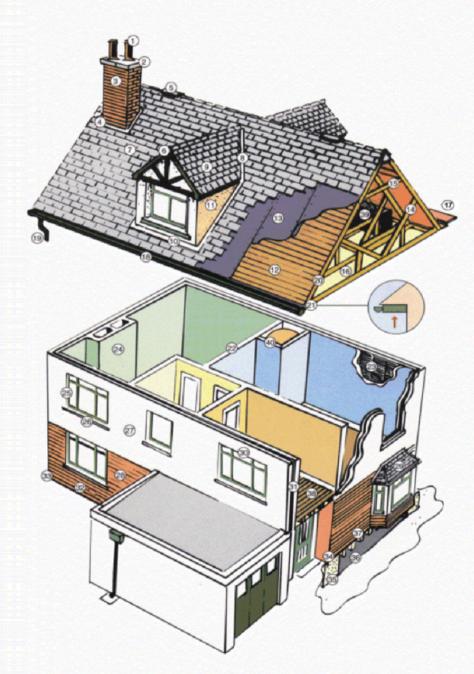
Sectional Diagram showing elements of a typical house

Reference may be made in this report to some or all of the above component parts of the property. This diagram may assist you in locating and understanding these items.

- **Chimney pots**
- Coping stone
- Chimney head
- Flashing
- Ridge ventilation
- 6 Ridge board
- 7 Slates / tiles
- 8 Valley guttering
- 9 Dormer projection
- 10 Dormer flashing
- **Dormer cheeks**
- 12 Sarking
- 13) Roof felt
- (14) Trusses
- (15) Collar
- 16 Insulation
- 17) Parapet gutter
- (18) Eaves guttering
- Rainwater downpipe
- 20 Verge boards /skews
- (21) Soffit boards
- (22) Partition wall
- 23) Lath / plaster
- 24) Chimney breast
- 25) Window pointing
- (26) Window sills
- (27) Rendering
- Brickwork / pointing
- 29 Bay window projection
- (30) Lintels
- 31) Cavity walls / wall ties
- 32) Subfloor ventilator
- 33 Damp proof course
- 34) Base course
- 35) Foundations
- (36) Solum
- 37) Floor joists
- 38) Floorboards
- (39) Water tank
- (40) Hot water tank
