YOUR ONESURVEY  
**HOME REPORT**

74 Maple Road  
Greenock  
PA16 9HS

# SINGLE SURVEY

A report on the condition of the property, with categories  
being rated from 1 to 3.

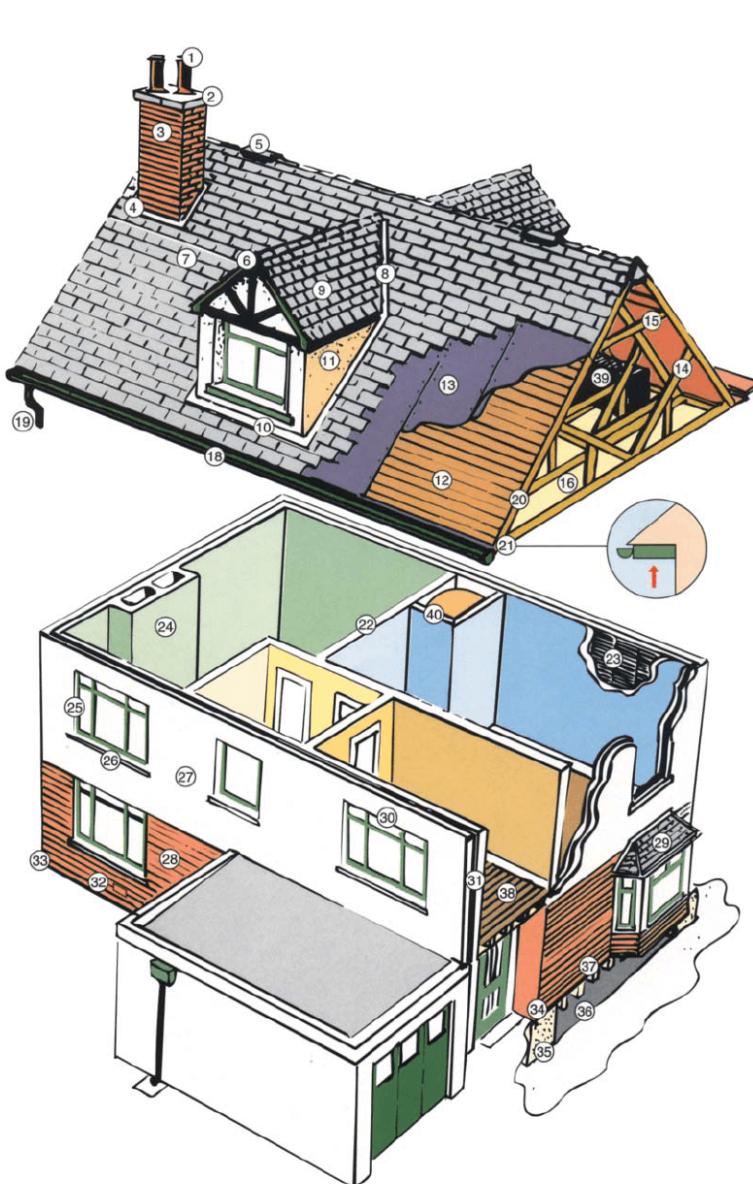
## Sectional Diagram showing elements of a typical house

- 1 Chimney pots
- 2 Coping stone
- 3 Chimney head
- 4 Flashing
- 5 Ridge ventilation
- 6 Ridge board
- 7 Slates / tiles
- 8 Valley guttering
- 9 Dormer projection
- 10 Dormer flashing
- 11 Dormer cheeks
- 12 Sarking
- 13 Roof felt
- 14 Trusses
- 15 Collar
- 16 Insulation
- 17 Parapet gutter
- 18 Eaves guttering
- 19 Rainwater downpipe
- 20 Verge boards / skewers
- 21 Soffit boards
- 22 Partition wall
- 23 Lath / plaster
- 24 Chimney breast
- 25 Window pointing
- 26 Window sills
- 27 Rendering
- 28 Brickwork / pointing
- 29 Bay window projection
- 30 Lintels
- 31 Cavity walls / wall ties
- 32 Subfloor ventilator
- 33 Damp proof course
- 34 Base course
- 35 Foundations
- 36 Solum
- 37 Floor joists
- 38 Floorboards
- 39 Water tank
- 40 Hot water tank

Reference may be made in this report to some or all of the above component parts of the property. This diagram may assist you in locating and understanding these items.

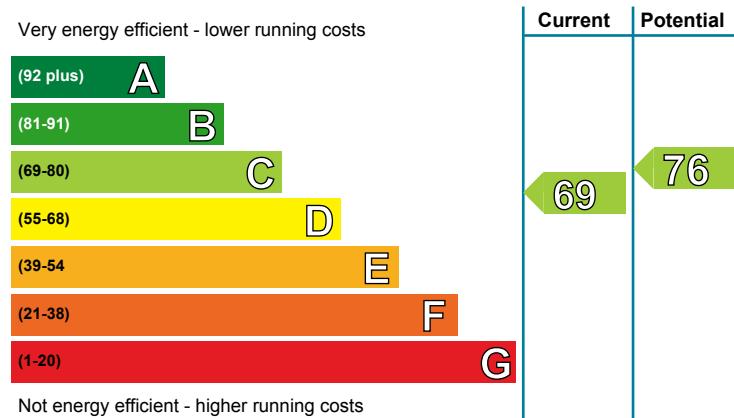
## Energy Efficiency Rating

This graph shows the current efficiency of your home, taking into account both energy efficiency and fuel costs. The higher this rating, the lower your fuel bills are likely to be.

Your current rating is **band C (69)**. The average rating for EPCs in Scotland is **band D (61)**.

The potential rating shows the effect of undertaking all of the improvement measures listed within your recommendations report.

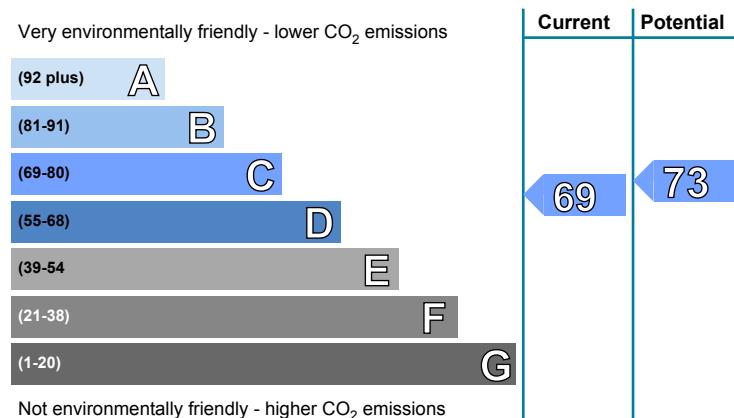
## Environmental Impact (CO<sub>2</sub>) Rating

This graph shows the effect of your home on the environment in terms of carbon dioxide (CO<sub>2</sub>) emissions. The higher the rating, the less impact it has on the environment.
