YOUR ONESURVEY
HOME REPORT

75 Kirn Drive
Gourock
PA19 1EG

SINGLE SURVEY

Surveyor Reference	MM
Customer	Mr. John Anderson
Selling address	75 Kirn Drive Gourock PA19 1EG
Date of Inspection	28/01/2026
Prepared by	Michael McDade, MRICS J & E Shepherd - Greenock

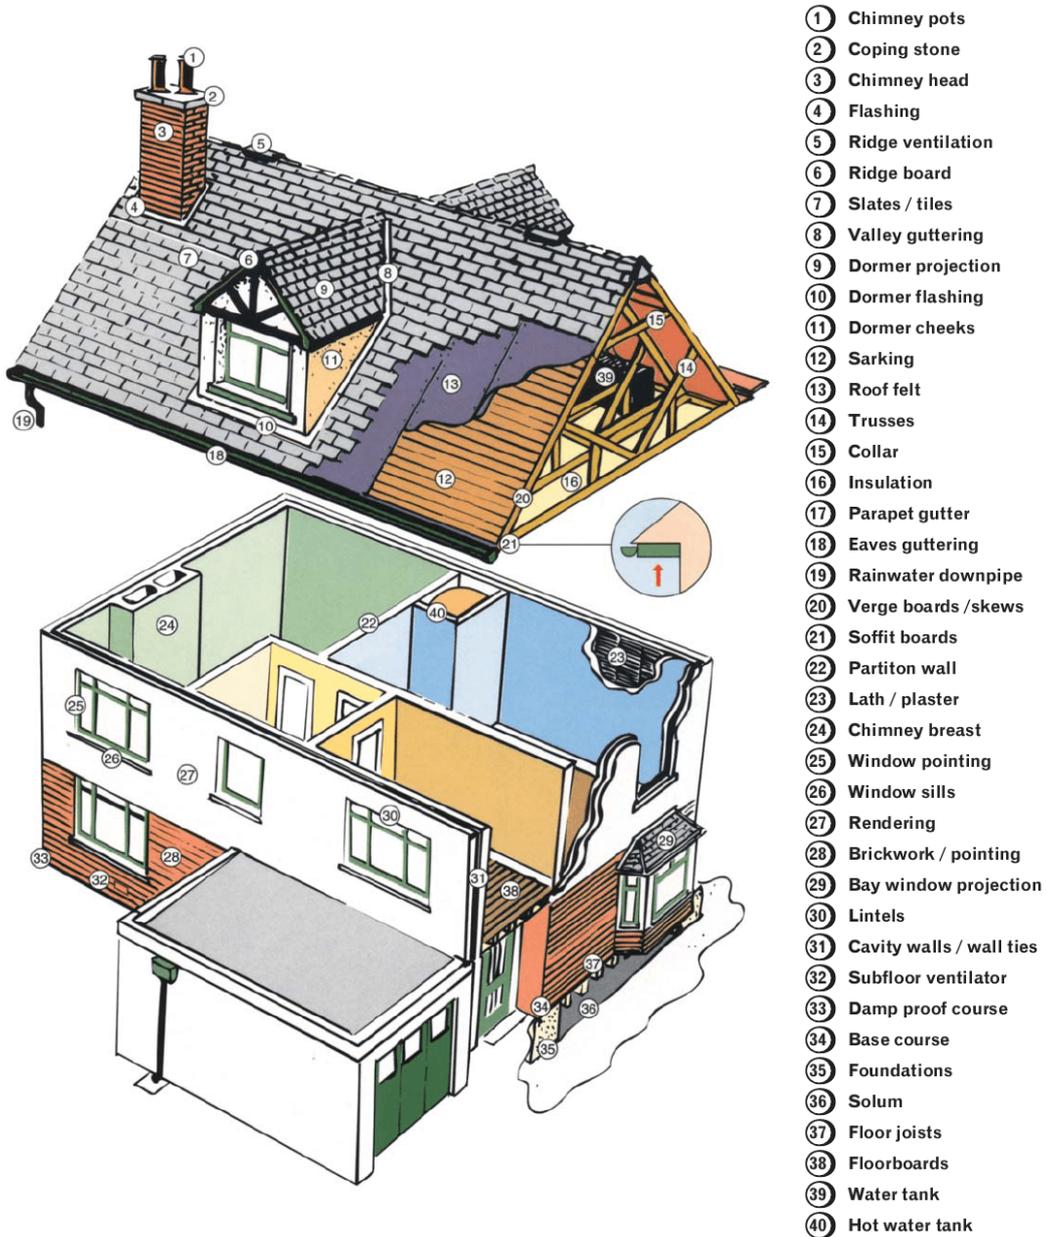
Sectional Diagram showing elements of a typical house

Reference may be made in this report to some or all of the above component parts of the property. This diagram may assist you in locating and understanding these items.

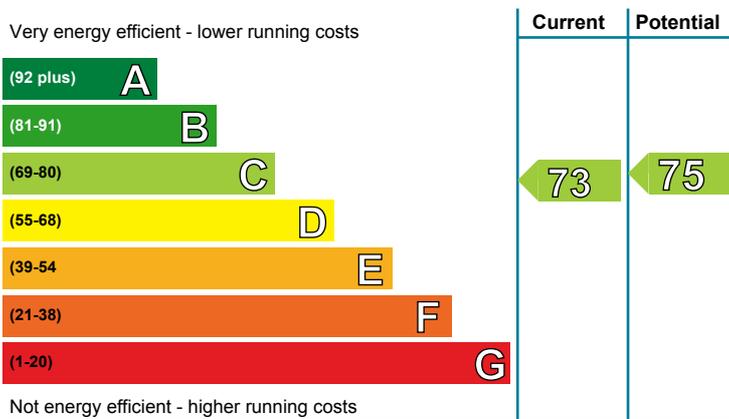
Energy Efficiency Rating

This graph shows the current efficiency of your home, taking into account both energy efficiency and fuel costs. The higher this rating, the lower your fuel bills are likely to be.

Your current rating is **band C (73)**. The average rating for EPCs in Scotland is **band D (61)**.

The potential rating shows the effect of undertaking all of the improvement measures listed within your recommendations report.

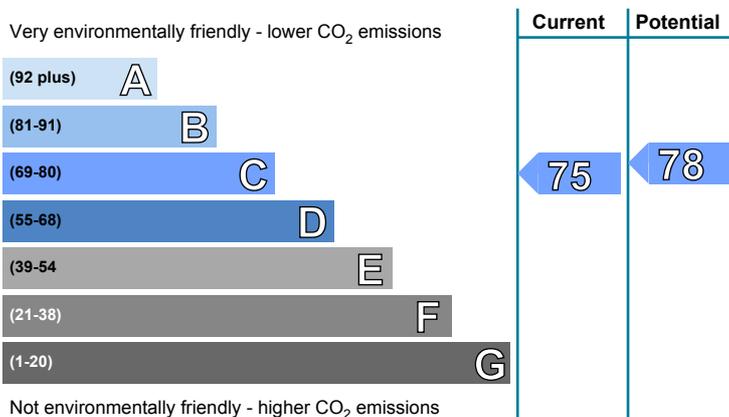
Environmental Impact (CO₂) Rating

This graph shows the effect of your home on the environment in terms of carbon dioxide (CO₂) emissions. The higher the rating, the less impact it has on the environment.
