YOUR ONESURVEY  
**HOME REPORT**

2/2  
4 John Street  
Gourock  
PA19 1PR

# SINGLE SURVEY

# Single Survey

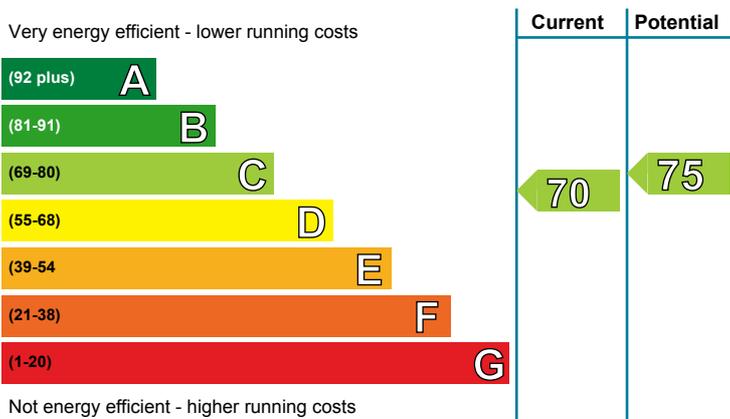
## Energy Efficiency Rating

This graph shows the current efficiency of your home, taking into account both energy efficiency and fuel costs. The higher this rating, the lower your fuel bills are likely to be.

Your current rating is **band C (70)**. The average rating for EPCs in Scotland is **band D (61)**.

The potential rating shows the effect of undertaking all of the improvement measures listed within your recommendations report.
