Single Survey

Survey report on:

Property Address	24 Finbraken Drive Gourrock PA19 1BF
Customer	Mr A Kayes & Mrs M Kayes
Date of Inspection	13/02/2025
Prepared by	Andrew G Scrimgeour Harvey Donaldson & Gibson Chartered Surveyors

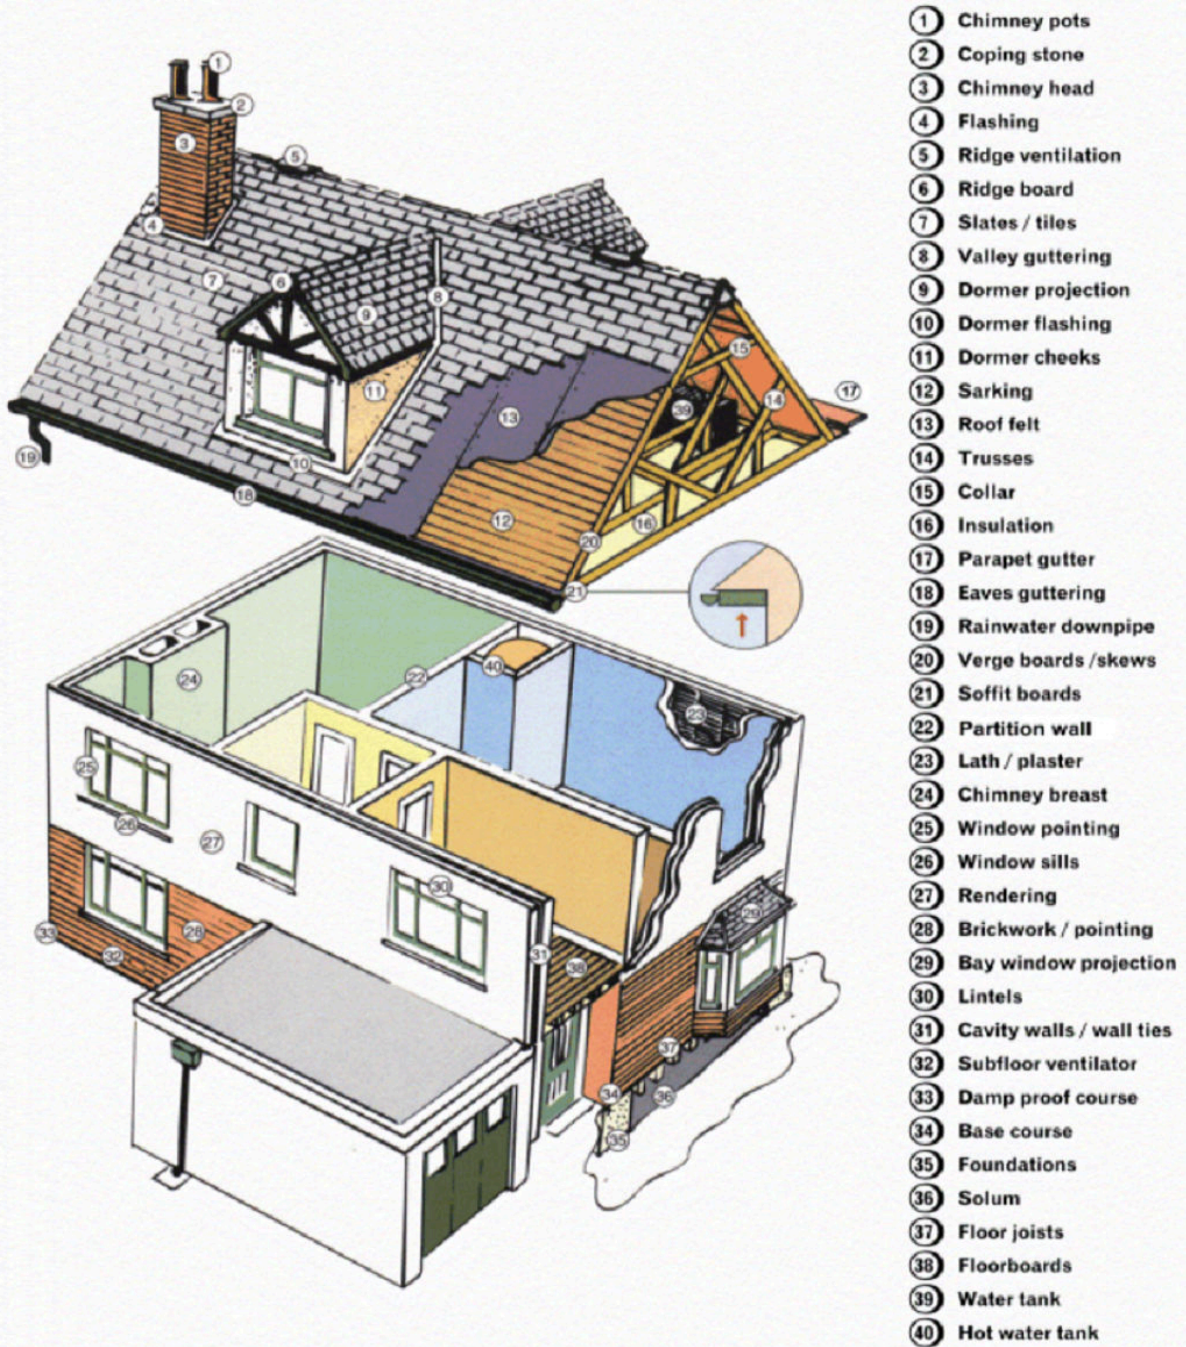
Sectional Diagram showing elements of a typical house

Reference may be made in this report to some or all of the above component parts of the property. This diagram may assist you in locating and understanding these items.
